## Test Report

Our Ref: GBW Number 2011000193 Issue 1 Date 09/03/2011 Page 1 of 3

### SALT SPRAY TESTING OF TIMCO FIRMAHOLD COLLATED NAIL SAMPLES

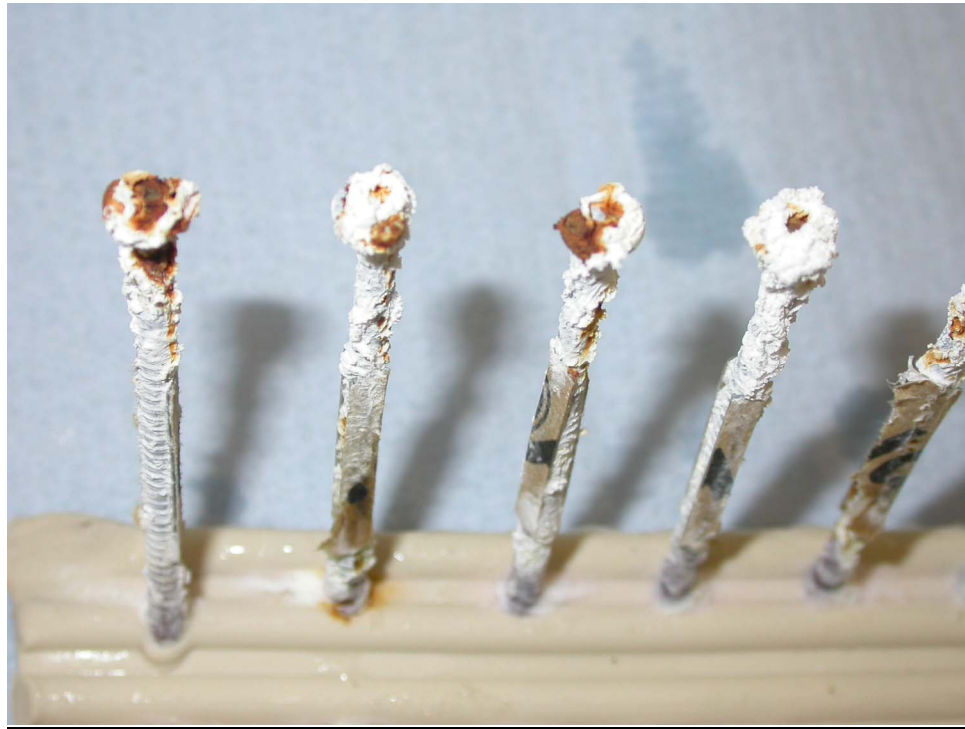
Fig 1

The samples showed evidence of significant red ferrous corrosion on the heads.

The photograph showing the condition of the Timco Firmahold Collated Nail Samples after 168 hours Salt Spray Test
